# PENNSYLVANIA STATE ROUTE 219

## THE BACKGROUND

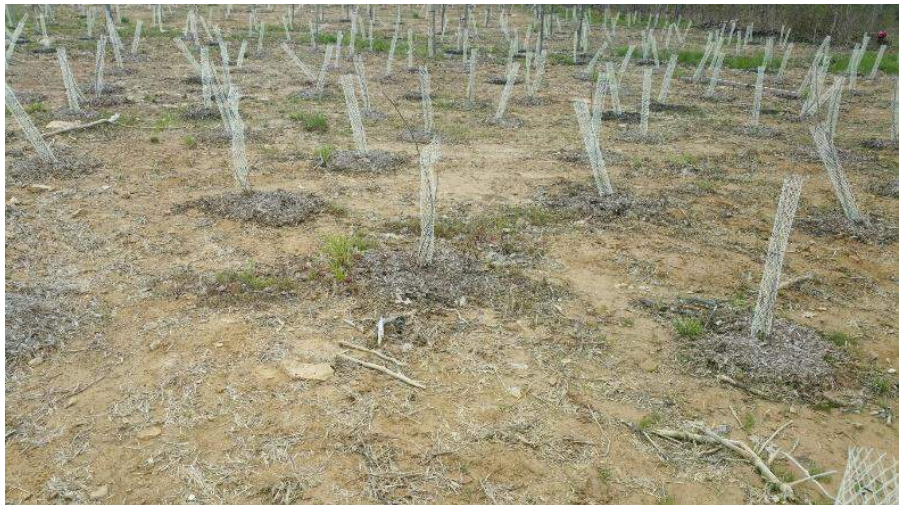
The first challenge came when it was time to restore and vegetate the wetland area. The top soil that was moved aside during the construction was in poor condition. Because a plan had not been in place for preserving the top soil it was lacking the nutrients needed for regrowth. Willows, surrounded by mulch, were the only vegetation in the wetland area. PennDOT had seeded the area three times with no success. The Engineering, Architecture and Design Services

(EADS) Group asked for our help. Our first step was a soil test. We found the soil was deficient in nutrients and macros. The organic composition of the soil was less than 1% and the pH was between 4 and 5. The second challenge was to amend the topsoil with the nutrients and organic matter required to make it sustainable for re-establishing vegetation. The third challenge was application of the amendments. The first thought was to import mushroom compost, which would have to be tilled into the soil. This presented a challenge as there was limited access for equipment to the area. To till the material into the soil it would have to be done around each of the existing willows.

Upon receiving the soil test results, the team at Triton Environmental recommended The Biotic Soil System featuring Biotic Earth Black. In addition, we used pH adjusters and fertilizer. The Biotic Earth Black was utilized to provide the necessary organic matter to the soil. All the amendments, except for the fertilizer, were applied topically through a hydroseeder with no tilling required. A hose was run from the hydroseeder to the cell which was over 100 feet away, taking care of the accessibility issues. This method allowed us to spray and cover the entire area without having to place the amendments around the willows and till them in. In an effort to protect the willows, the fertilizer was applied by hand.

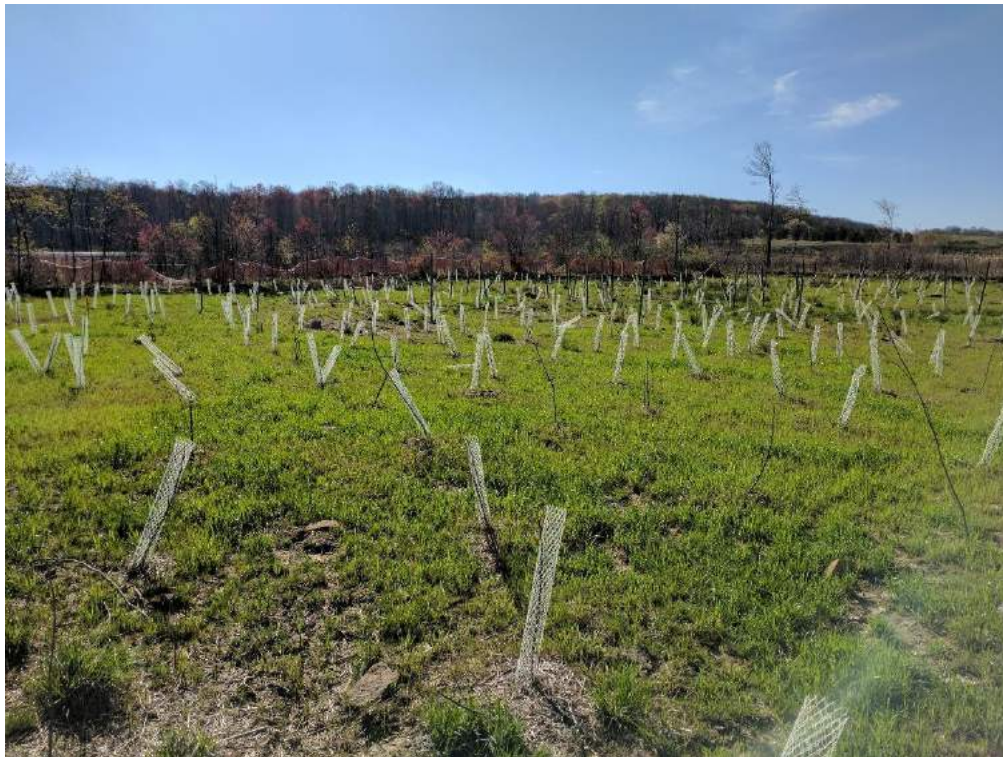
The initial application, which was applied in late October, was germinating within two weeks of the application. The area was fully vegetated by early spring. The mix of amendments provided the necessary nutrients to establish and sustain vegetation, with an efficient application process. This is a process that can be used on even the most challenging sites.
