## WELD COUNTY EMERGENCY FLOOD REPAIR

## THE SOLUTION: THE PERSEPHONE SYSTEM

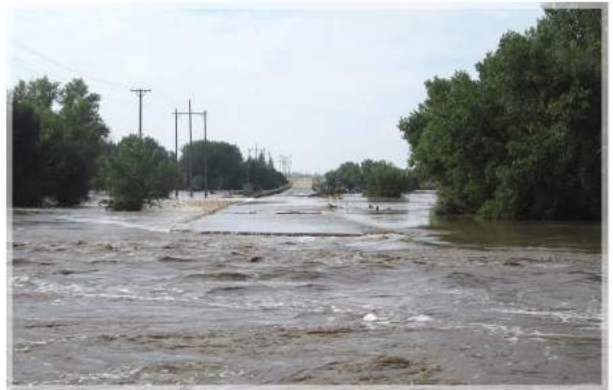
*September 2013*

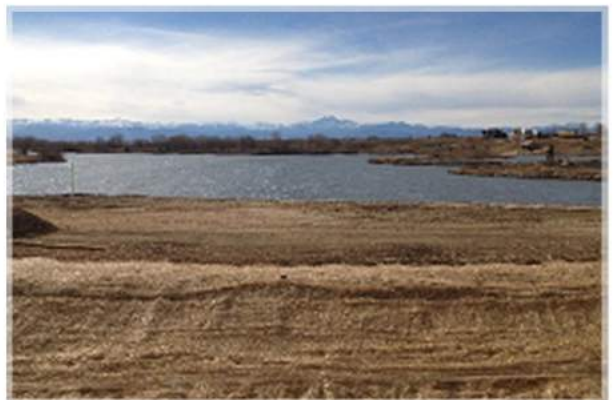
*March 2014- area repaired, and blanket set to protect from erosion*

In order to establish immediate soil stabilization, Propex Global Solutions' high-performing Turf Reinforcement Mating (Landloc 300) was used in its Armor Max system to prevent any further erosion of the newly established topsoil complex. Due to the highly erodible properties of the soil, 18" anchor pins were used to reinforce the system's foundation and enhanced the seed to soil contact. The finishing elements of the system included a second layer of the seed, organic fertilizer and Biotic Earth matrix, which included Earth Bound 2000 soil flocculent, secured in place with a 100% biodegradable netted straw blanket.

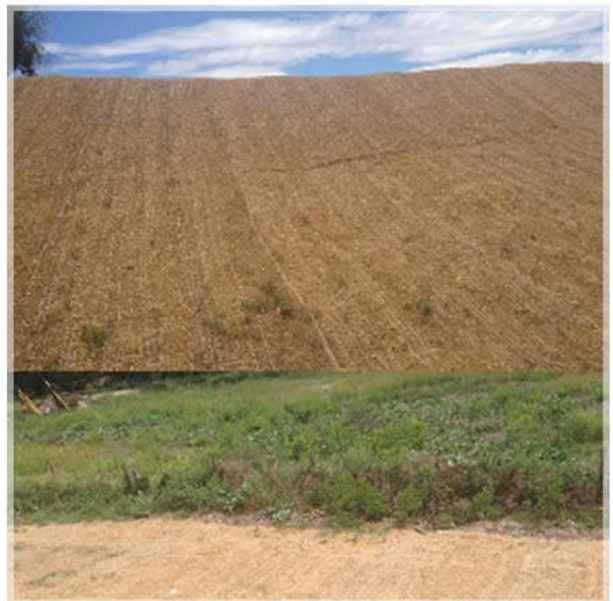
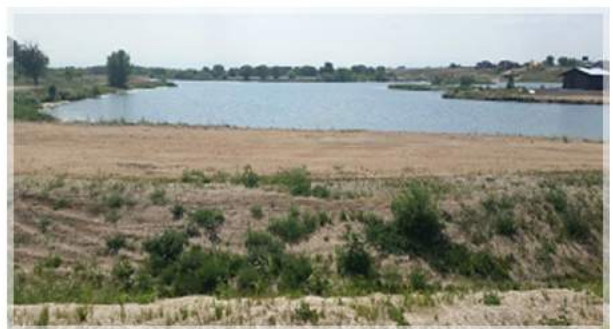
*June 13, 2014- Weld County Road*

Vegetation began establishing less than 2 weeks after the system was applied. From May 2014 to August 2014 the vegetation began to stabilize the slope. Given the past success of The Persephone System in its ability to drastically decrease the germination rate of the seed, Triton was confident that the implementation of this system would lead to the success that was strived for during the flood repairs. Even with the severity of these sights' erosion damage, the high vegetation growth rate can be credited to the addition of Verdyol's Biotic Earth HGM matrix that created the ideal nutrient rich system for maximum plant growth. However, establishing vegetation would not have been possible without the high performance levels of the Propex Armor Max system to prevent erosion, coupled with Triton's soil amending system to create the ideal environment for maximum plant growth. Each necessary component of The Persephone System worked cohesively and successfully towards the challenge of re-vegetating these severally damaged areas.
